SM Solutions

Article by John Titus

Of SMs, Washing Machines, and Water Pump Seals

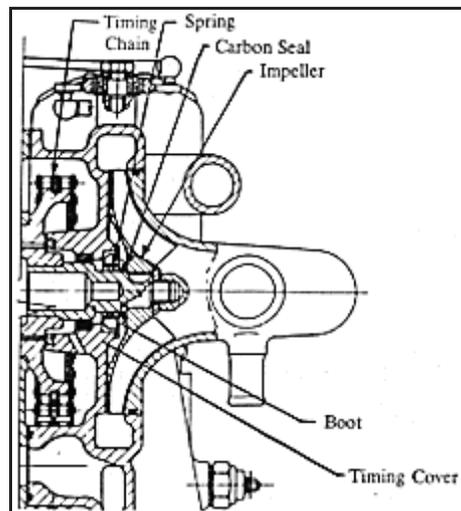
water pump seal but a pretty good one for

The SM water pump seal is a truly bizarre design for a pressure relief valve. I have heard that the seal was adapted from, or is identical to, a seal used in a British dishwasher or washing machine. I don't know if this is true, but it makes for a good story, and anyway the seal looks like a scaled-up version I put in my wife's dishwasher a few years ago.

The seal comprises of a rubber boot seated in the timing cover around the end of the jackshaft on which the water pump impeller is mounted. The boot holds a carbon sealing element at the end opposite the timing cover and encloses a spring that pre-loads the carbon element. Unlike normal water pump seals, which usually have a cast iron or stainless steel seat to ride on, in the SM seal, the carbon element rides directly on the back of the soft bronze water pump impeller. Also, unlike normal water pump seals, which have no taper and are thus ineffectual to the effects of the water pressure they are sealing, the SM seal has a step and taper from a diameter of 1.70 inches at the timing cover to an outer diameter of 1.25 inches at the sealing face. This provides a pressure area of 1.04 square inches at the sealing face. This system pressure, tends to lift the seal face off the back of the impeller and leak coolant to relieve the

Because the spring in the SM seal is inside the engine rather than inside the cooling system, the spring is exposed to the higher engine interior temperatures, which may lead to a loss of spring force. Finally, the outer edge of the carbon on the pressure side is beveled, at least on some units. A bevel on the pressure face will tend to facilitate debris working under the seal, which causes premature scoring of the seal surface.

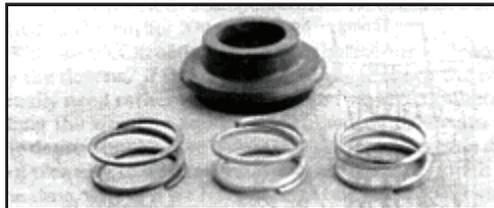
When the seals arrived, I was surprised to see that Don's springs had only 2 1/2 coils and thus would be stiffer than the 3 coil springs in the new factory replacement springs, so I grabbed all of the old SM water pump seals I had (I never throw any uniquely SM part away, no matter how bad the condition) and I removed the springs. Much to my surprise, I discovered that the springs in the older seals were different from the springs in the newer seals. This led me to conclude that some SM water pump seals being sold today as original replacement parts have a substantially weaker spring than the original parts and thus will not hold proper cooling system pressure.

By comparison, the "factory replacement" CF28783 spring has a theoretical rate of only 33 lb/in and when compressed to the same installed height of .28 inches will exert a force of only 6.3 lbs! (Suitable use for a washing machine, perhaps, but insufficient for an automobile engine.)

On the left is the J.B.M. spring, which, being made of a chrome-vanadium alloy, is darker than the stainless steel springs. The middle spring is the WPF087 spring and the spring on the right is the flimsy CF28783 spring. An assembled, J.B.M. reproduction seal is shown in the background. Incidentally, the J.B.M. seal is properly designed without an outside bevel, and thus will exclude debris from the seal surface better than the GACO seals with the outside bevel.

Based on the above data, my advice to any SM owner contemplating a water pump seal replacement is that you check the markings on the replacement seal. If the seal is marked CF28783, or even if it is not, look at the spring inside. If the spring has 3 complete coils, remove and discard the spring and re-use the spring from the seal you are replacing, assuming it is the WPF087 2 1/2 coil variety. The spring can easily be removed by grasping the seal at the metal cup end and, using thump pressure on the outside, turn the base portion of the rubber boot inside out to eject the metal cup. Placed side-by-side, the difference in the diameter of the wire used in the two springs is unmistakable. If you have no serviceable springs, my only advice is to buy a new J.B.M seal, which is guaranteed to have a serviceable spring. Save the CF28783 seal in your inventory for the next water pump job and, when the time comes, simply re-use the spring from the J.B.M. seal. If you have your seal replaced by a service facility, give them the above information and demand that a system pressure test be done to verify the integrity of the seal. If it doesn't hold at least 5-7 psi, a defective CF28783 seal was installed. Demand that it be replaced with a WPF087 or a J.B.M. seal.
